Chapter 6, another of our longest, embraces folk and vernacular architecture. But, again, the South-eastern Crescent appears, with Louisiana, Alabama, Georgia, Pennsylvania, New Jersey, and Ontario being better represented. The deficiencies in the eastern United States and virtually all of the Midwest, West, and Canada, as well as the nearly complete absence of studies of modern structures, glowers out at us.

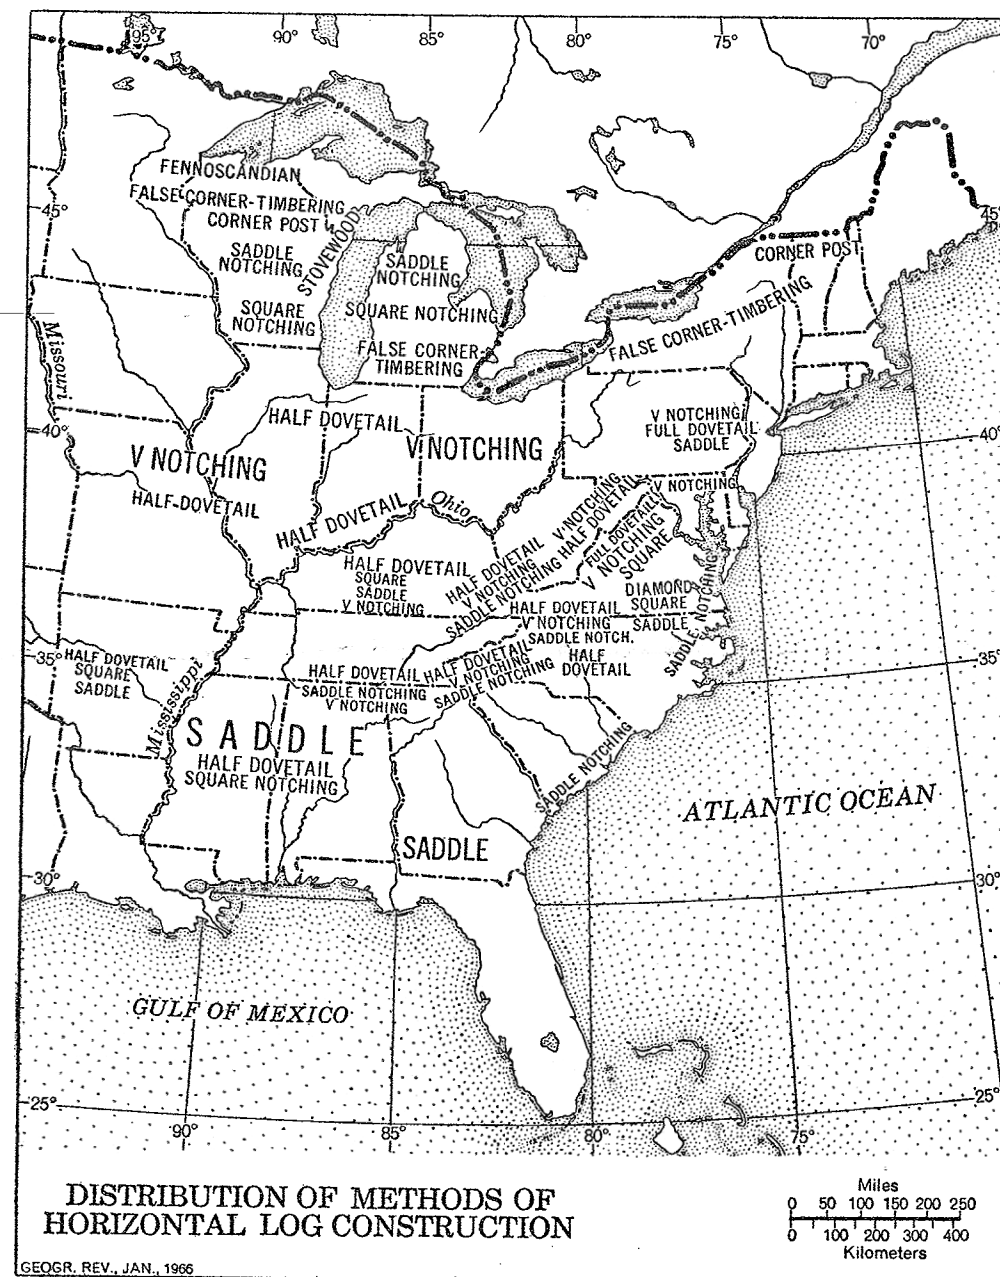
FIG. 28—Distribution and dominance of methods of horizontal log construction. Based on approximately one thousand individual examples. Differences in weight of terms are indicative of relative importance.

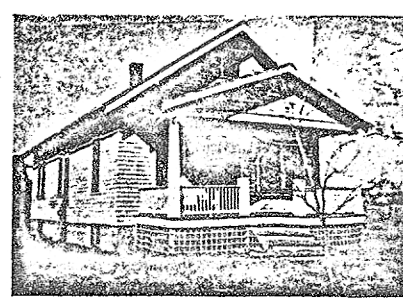
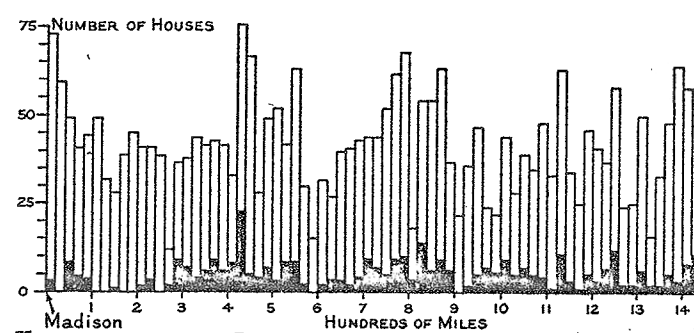
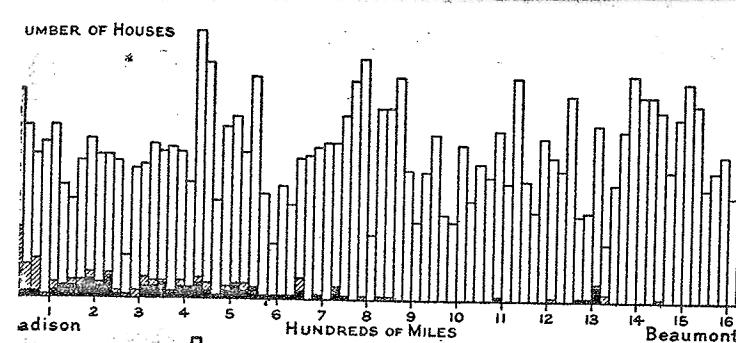
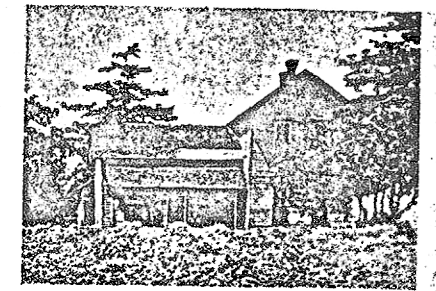
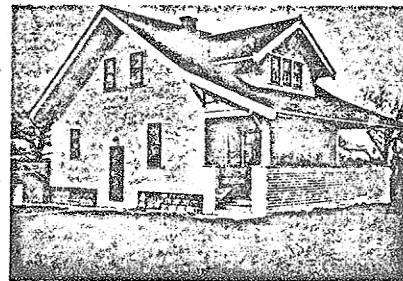
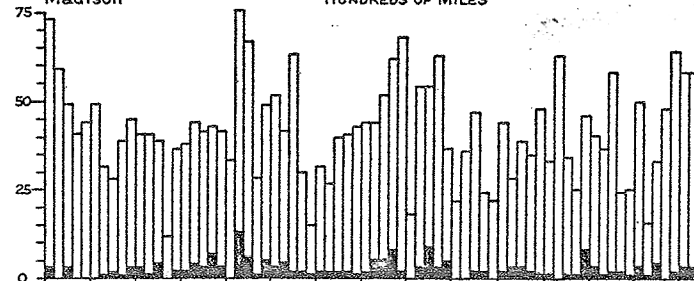
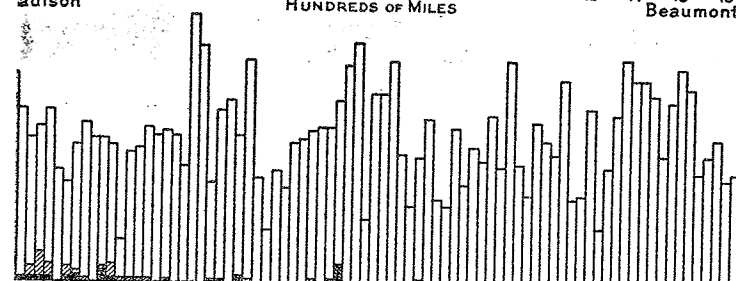
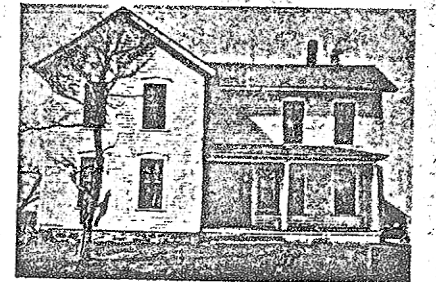
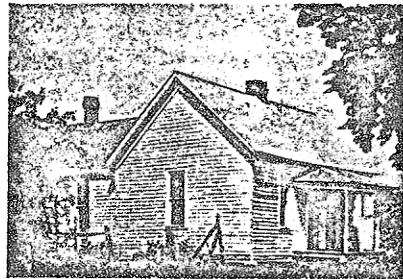
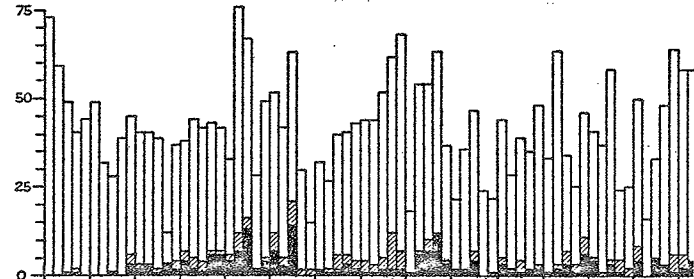
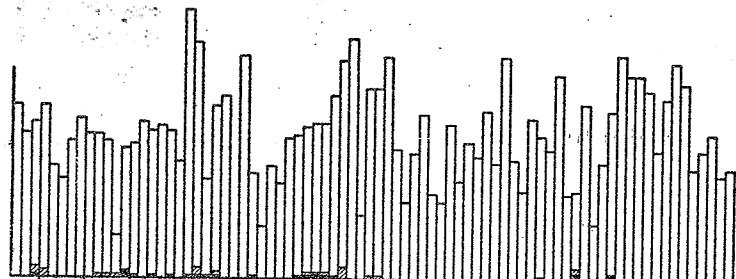
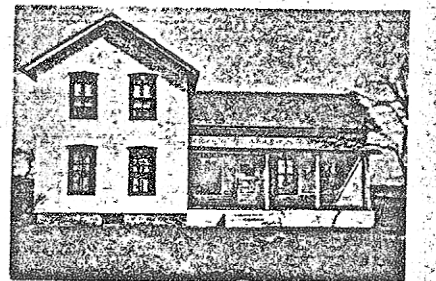
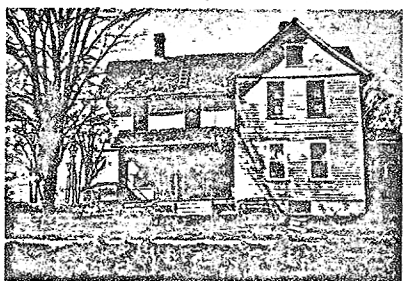
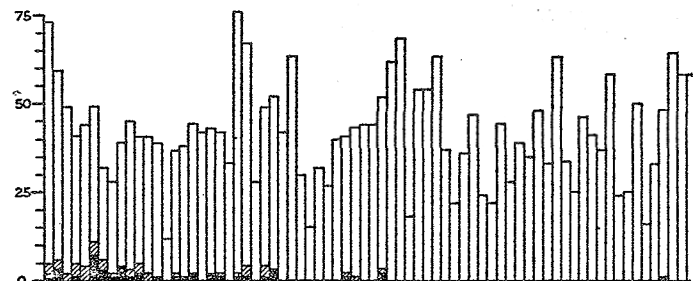
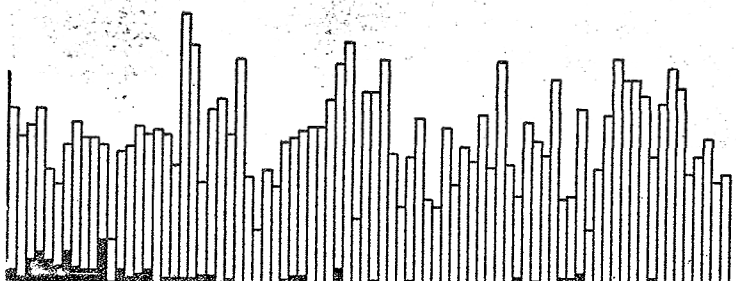
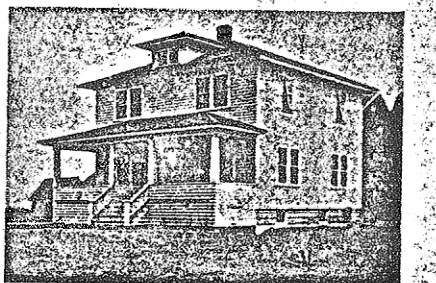
FIGS. 2-17—Profiles of dispersed dwelling types on traverse between Madison, Wis., and Beaumont, Tex. (see Fig. 1).

FIGS. 2-4—Well distributed types (A). FIG. 2—Bungalow A. One story high, two rooms wide, two rooms or more deep; ridge of roof perpendicular to front. Porch may be like that shown or smaller, or it may be built in under a continuation of the roof, either extending the width of the house or with one room at side. Seems to be of fairly recent origin and is in fair to good condition of upkeep.

FIG. 3—Bungalow B. Differs from Bungalow A in more nearly square form of ground plan, greater height in proportion to lateral dimensions, and ridge of roof parallel to front of house. At least two rooms deep. Usually has dormer window. Porch variable or lacking. Upkeep better than average.

FIG. 4—One-story T house. Simple, one-story dwelling with T-shaped ground plan. Two subtypes: (a) with crossbar of T parallel to front (black bars); (b) with crossbar perpendicular to front (ruled bars). The difference in orientation not only results in a different placement of porches and entrances but usually means a different orientation of the house with respect to the highway.

FIGS. 5-11—Types found predominantly in the North (B). FIG. 5—Two-story T house. Resembles one-story T in ground plan but has a larger base, attached porches, and usually a basement. Well above the average in quality. Two subtypes, as in one-story T houses.

FIG. 6—Two-story—one-story T, or Midwestern type. Crossbar of T two stories high; perpendicular; segment only one story. Porches of two-story portion attached; those of the one-story wing either attached or built-in. Quality slightly above the average. There may or may not be a basement. Subtypes as in one-story T houses. (See F. B. Kniffen: Louisiana House Types, *Annals Assn. of Amer. Geogr.*, Vol. 26, 1936, pp. 179-193.)

FIG. 7—Two-story L house. Resembles two-story T (Fig. 5) except that ground plan is L-shaped. Of slightly better quality than two-story T but has fewer representatives. Has a basement and attached porches. Two subtypes, in which front of house is (a) outside the angle formed by the wings (black bars), (b) within the angle of the L or in the end of one of the wings (ruled bars).

FIG. 8—Two-story—one-story L. Same ground plan as two-story L; roof profile like that of Midwestern type (Fig. 6). Two subtypes, as in two-story L houses. Has the fewest representatives of all the types.

FIG. 9—Two-story pyramid. A square structure with pyramidal roof, attached porches, usually a basement, and often a dormer. Substantially built; averages highest of all types in quality.

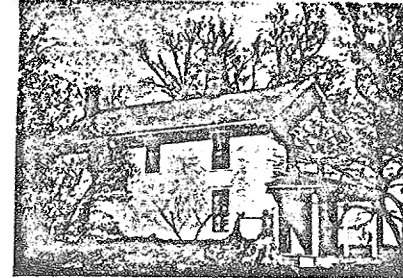
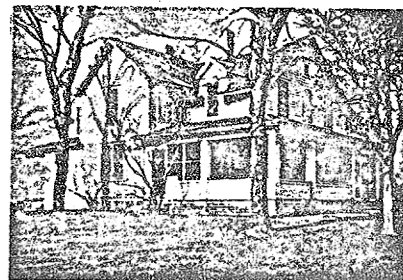
FIG. 10—Two-story linear house. Simply constructed, well built, with two-slope roof, ridge of which extends length of house. Depth greater than width. Porches attached almost without exception. Two subtypes, in which the main entrance is (a) at end of house (black bars), (b) at side of house (ruled bars).

FIG. 11—Corn Belt type. Although easily recognized when observed in the field, this is not strictly a type, since it lacks definite form and cannot be classified in terms of ground plan or roof. Characteristically a large, rambling, substantially built structure with seven rooms or more and a basement; usually well painted. It ranks high in quality; and its surroundings show evidence of present or past prosperity.

FIGS. 12-17—Types found predominantly in the South (C). FIG. 12—One-story L. Resembles two preceding L types in ground plan and orientation but is smaller and in poorer state of repair. Similar to one-story T (Fig. 4) in size and quality. Two subtypes, as in the other L types.

FIG. 13—Ozark type. A poor house, two rooms wide, one room deep; ridge of roof parallel to front. Exterior walls characteristically of rough, unpainted boards running vertically or of logs; foundation usually of low wooden blocks or loose stones. Occurs in Ozark hill lands of Missouri and Arkansas and southward to end of traverse. In Oklahoma and Texas commonly used as a tenant house.

FIG. 14—Shotgun type. A linear house, one room wide, three rooms deep; ridge of roof perpendicular to front. Usually has some form of attached or built-in porch across the front. Vertical boards characteristic of exterior walls; foundation usually of wood or stone blocks. Found mostly from the Ozarks southward.

FIG. 15—Shed-room type. Main part of house two rooms wide, one room deep, and one or one and a half stories high; ridge of roof parallel to front. Shed room with one-slope roof built against the back. Front porch may be either attached or built-in. Vertical boards and a block foundation again the rule. Ranks lowest in quality of all the types observed.

FIG. 16—One-room shack. A small dwelling with only one room; may have a simple one-slope roof or a ridge roof. Found principally in the Ozark and Ouachita hill lands but extends to south end of traverse. Ranks next to lowest in quality.

FIG. 17—One-story pyramid. Square house with pyramidal roof. Often well built and painted yet in general ranks below the average in quality. Porch either attached or built in under the roof. Occurs throughout traverse but is most prominent in the southern part and especially in the Black Prairie of Texas.

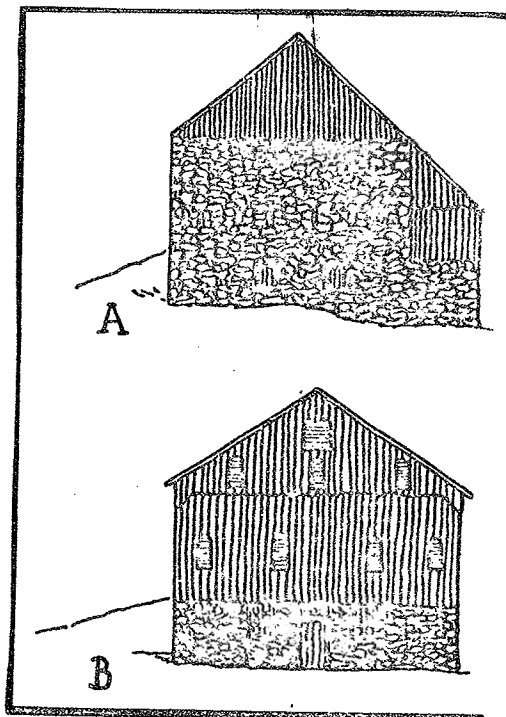
FIG. 11—Gable End Profiles of Barns Pennsylvania Type H. A) East of Le Loudoun County, Virginia (March, 19 Near Knoxville, Frederick County, M. (April, 1963).

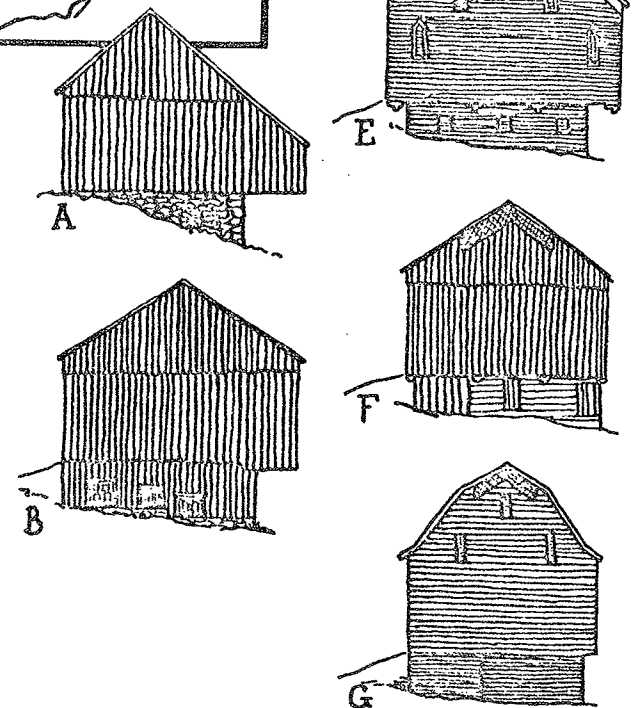
FIG. 4—Gable End Profiles of Barns of the Pennsylvania Type F-G. A) Near Monrovia, Frederic County, Maryland (May, 1963). B) In Accident, Garrett County, Maryland (August, 1963). C) South of Mt. Spring, Augusta County, Virginia (July, 1963). D) West of Daleville, Botetourt County, Virginia (Jul 1964). E) Between Waynesboro and Staunton, Augusta County, Virginia (August, 1962). F) Near Fairfield, Rockbridge County, Virginia (July, 1963). G) North of Shenandoah, Page County, Virginia (Jul 1964).
